## Editorial

The serious deterioration of Powder Point Bridge came into focus recently when the selectmen asked the Duxbury Fire Department to make a submarine study of the pilings and to report on the overall condition of the bridge. Here is a report that could have been written only by men in diving suits. Some of the computations made in connection with this report were, in fact, written by Deputy Chief Howard Blanchard while he was under water.

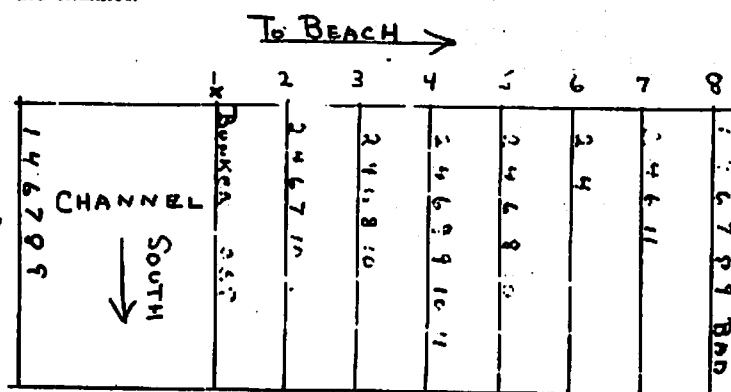
The chart below shows only a fraction of Powder Point Bridge, beginning with the channel and heading towards Duxbury Beach. It shows 16 spans under water and 33 spans Powder Point east to the channel.

Each span has from four to 12 pilings. There are more in the channel area because when new pilings were put in some of the old pilings were left floating.

Now note carefully: the numbered piles shown in this sketch (made on May 27, 1971) are NOT SUPPORTING ANY LOAD.

Note further that the 16 spans under water are never exposed to the elements, even at dead low tide.
